Moisture Content of Laminated Beams in use In The Rocky Mountain Area

USDA Forest Service Research Paper RM—73_{//} June 1971
Rocky Mountain Forest and Range Experiment Station
Forest Service
U.S. Department of Agriculture

Moisture Content of Laminated Timbers in Use in the Rocky Mountain Area

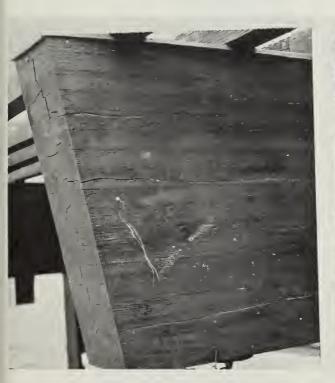
The slightly higher than average exterior moisture contents shown for structures 6 and 11 (table 1), while of relatively minor magnitude, are nevertheless worthy of further mention since they represent a problem condition common to laminated structures in the area. In both cases, content was high in a short, exposed end section. In both instances the timber was rather severely checked (fig. 8) because of the rapid wetting and drying of the exposed end grain under severe drying conditions.

The degree of checking shown in figure 8 will concern the owners of a structure, and is a very common problem in the Rocky Mountain area, especially in southerly or westerly exposures, because of the high intensity of the sunlight. In some instances metal caps or end coatings have been applied to control or mask the problem.

Figure 8.--End section of laminated timber in Test Structure 6 shows severe checking from rapid moisture content changes under exterior unprotected exposure.

4. The higher EMC values associated with end grain in exterior unprotected timbers could likely be reduced through improved design or through the application of effective coatings

7. Southerly and westerly exposures will be especially severe for end sections of laminated timbers. To assure satisfactory performance, designers should avoid such exposures or provide effective protection.
